Re: Notice of Violation  
Compliance Evaluation Inspection  
EPA ID No.: WID006078844

## RCRA COMPLIANCE EVALUATION INSPECTION REPORT

**SITE NAME:** Pentair

**DATE OF INSPECTION:** September 12, 2012

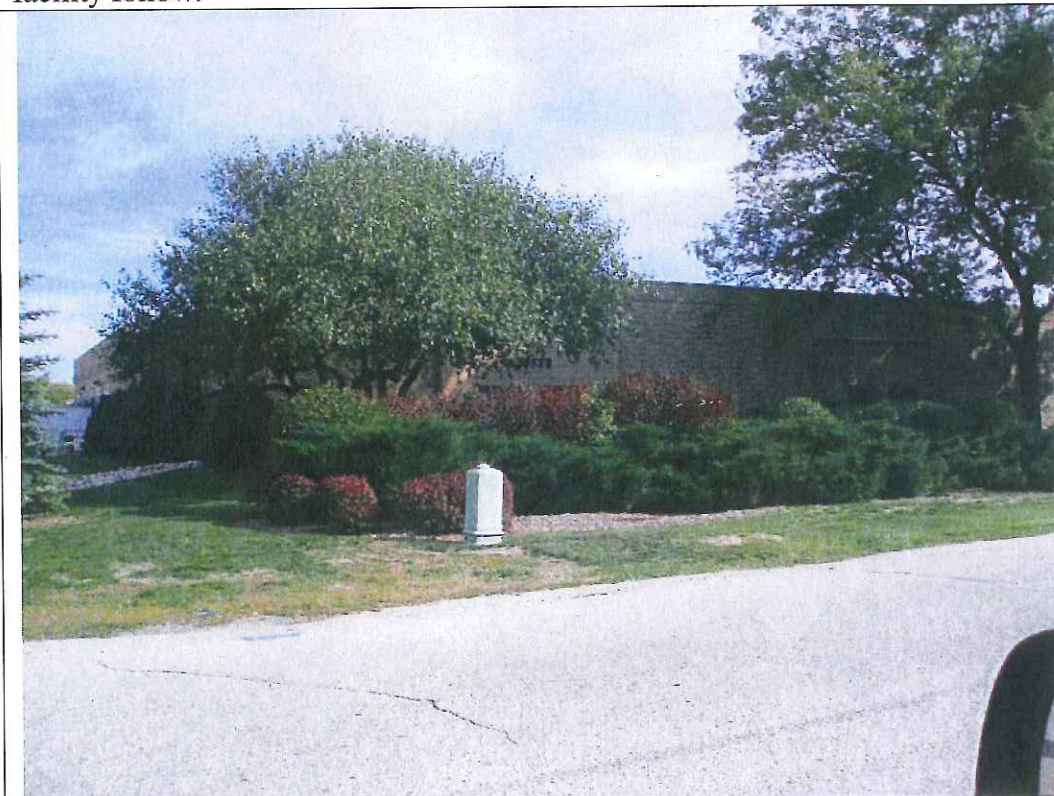
**Picture #:**  
P9110065  
**Date:** 9/11/12,  
9:31 a.m.  
**Photographer**  
: Sue Brauer  
**Location:**  
Pentair, WID  
006078844  
**Subject:** West  
end of building  
from car  
headed east.

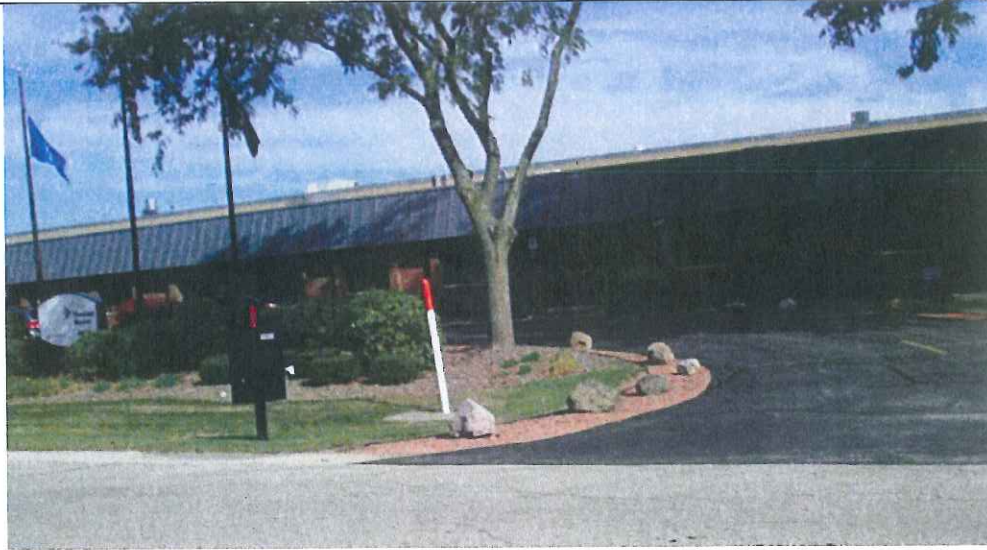
**Picture #:**  
P9110066  
**Date:** 9/11/12,  
9:32 a.m.  
**Photographer**  
: Sue Brauer  
**Location:**  
Pentair, WID  
006078844  
**Subject:** East  
end of  
building,  
including sign  
and entrance.  
Pavement at  
the photo  
bottom was  
cropped.

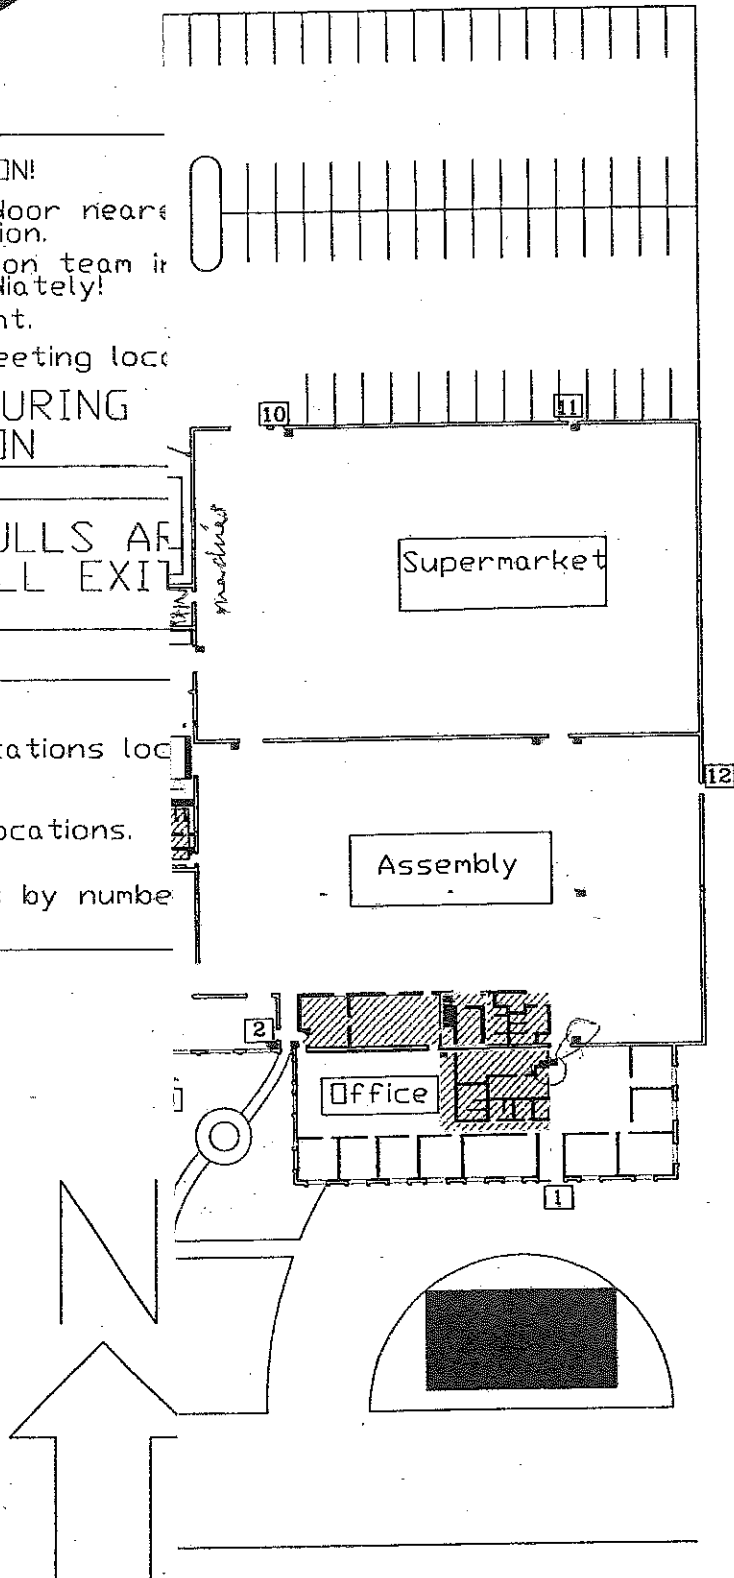
A-2

The 2010 evacuation map shows a blocked doorway between the Assembly and Subassembly Areas. As pointed out by Mr. Hintz, this doorway is no longer blocked.
